Joseph Rowntree Memorial Library

Desk Based Assessment
Christopher Berriman MA

Completed for Cultural Heritage
Management MA with the University of York

Desk-Based Assessment

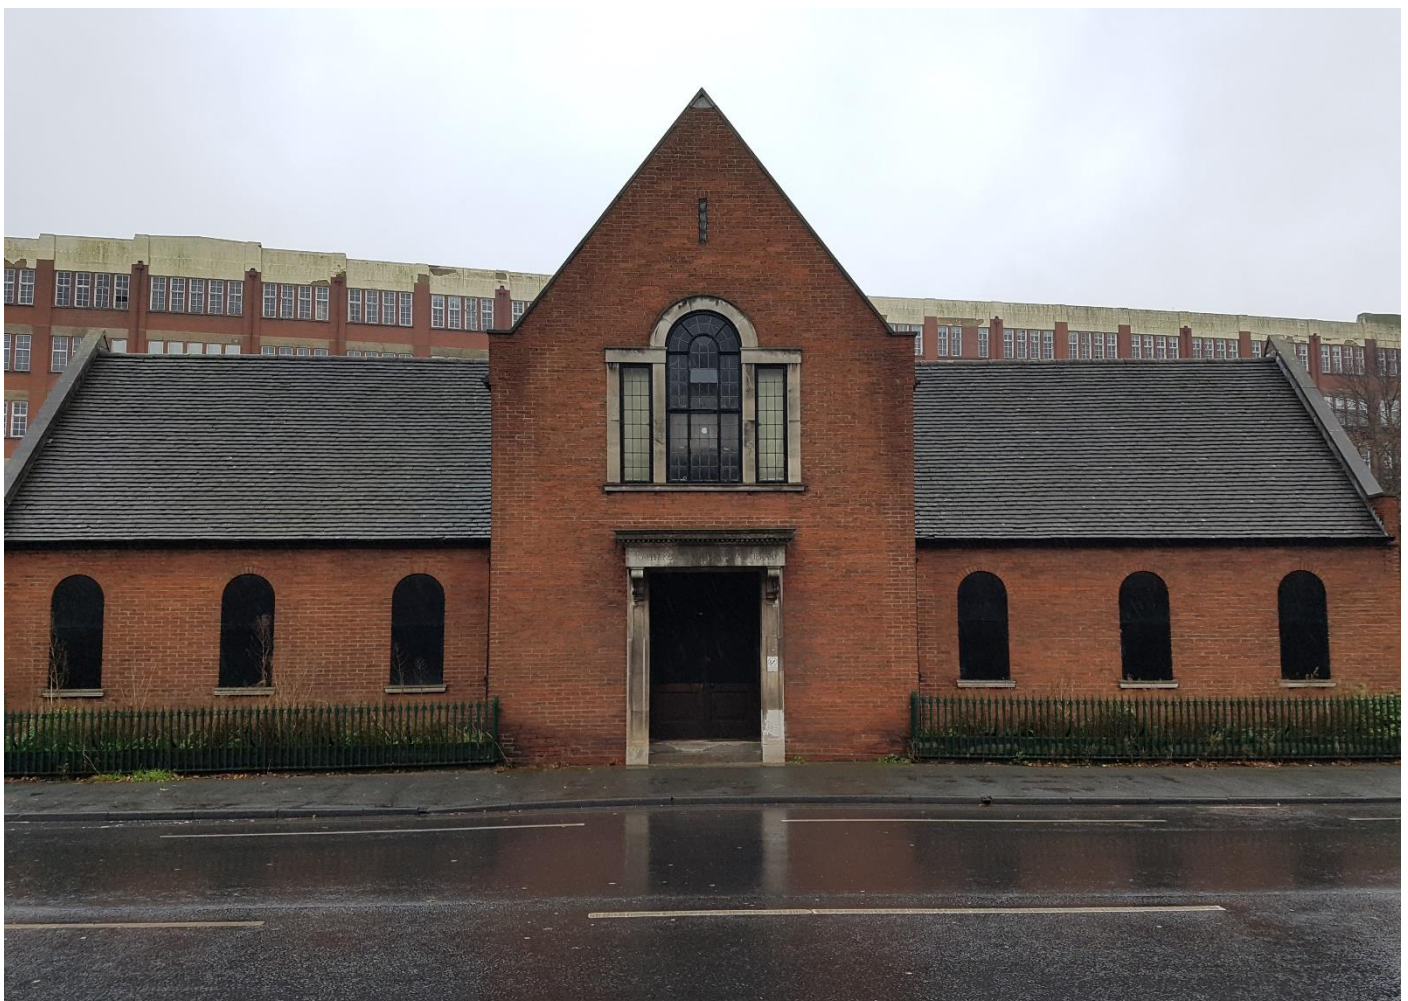
FIGURE 7

The pointing is flush to the brick, however the lower portion of the external mortar pointing has a range of issues at various points around the building, as examined on the southern and eastern elevations. Figure 7 shows an example of these issues, which include black stains, suggesting algal growth, as well as weathered, eroded and open mortar joints suggesting a failure in the mortar following weathering (Historic England, 2015, 539-41).

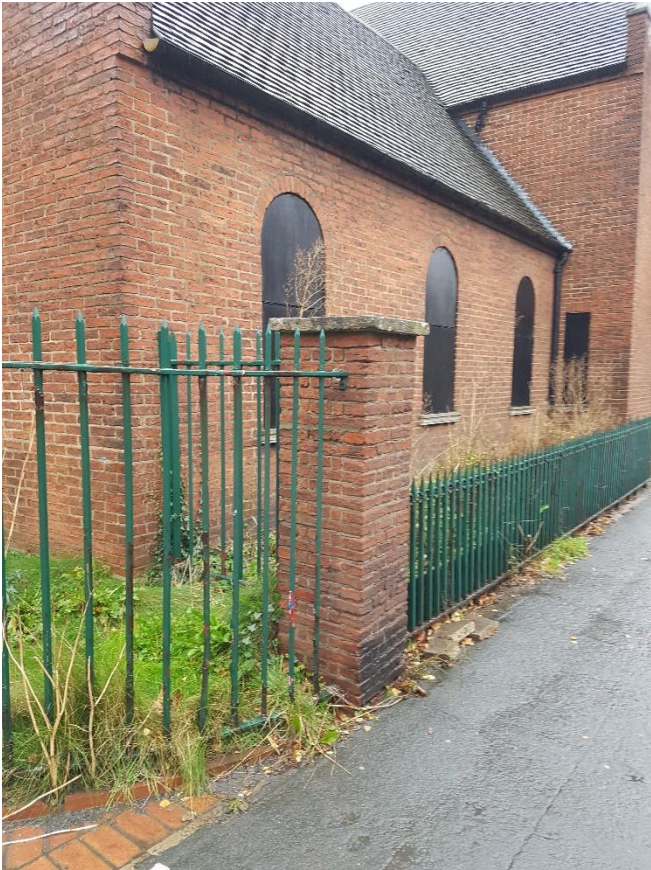
FIGURE 8

Around the Library there are several brick columns, from which a metal fence runs around the perimeter of the south, east and north elevations, terminating in columns

which adjoin the large entrance gates to the facilities behind the Library itself (Figure 8).

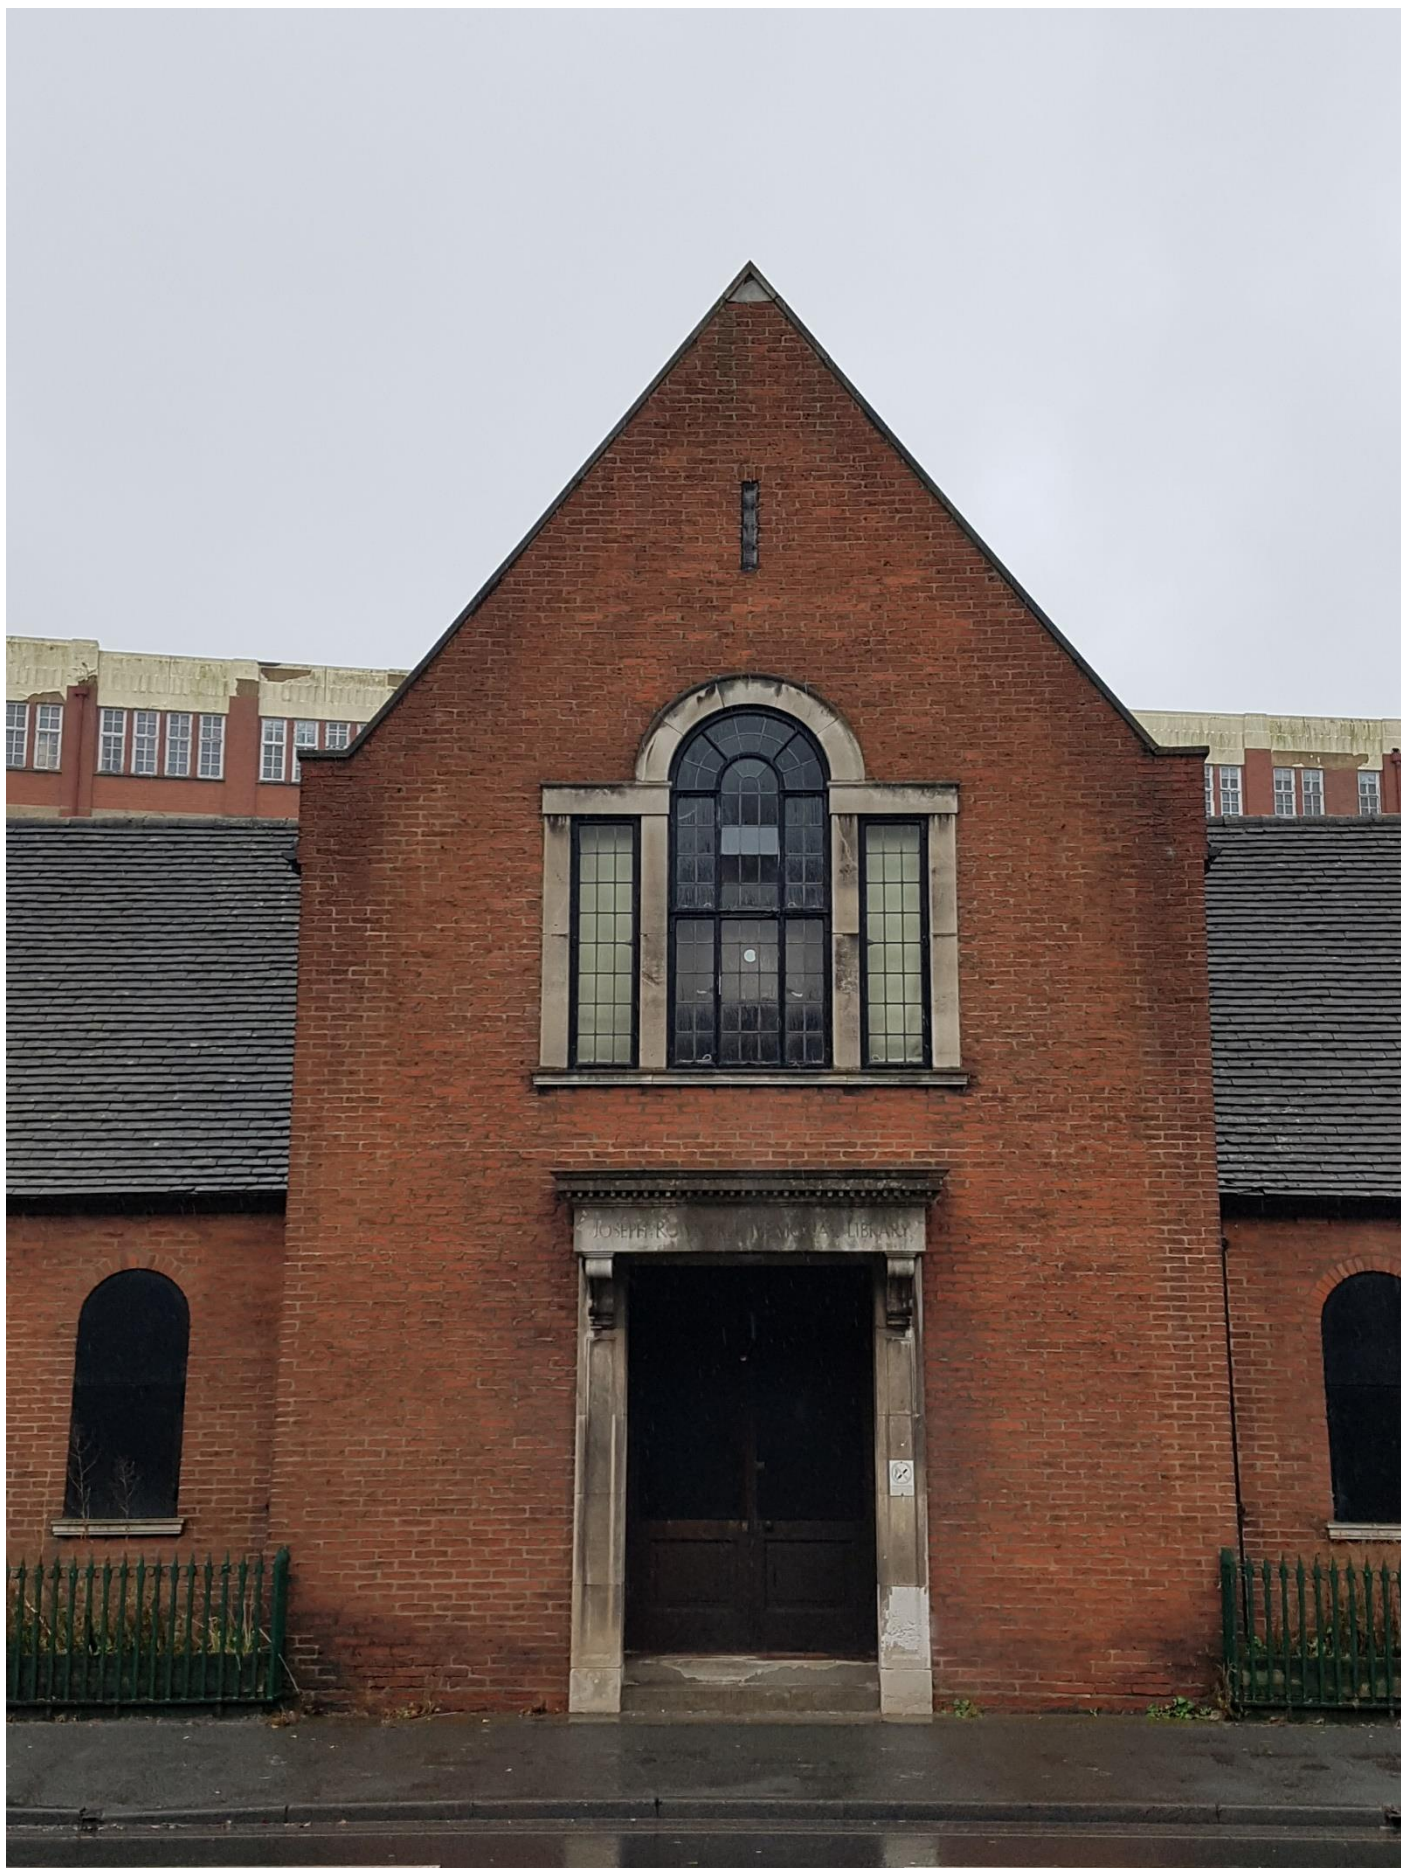
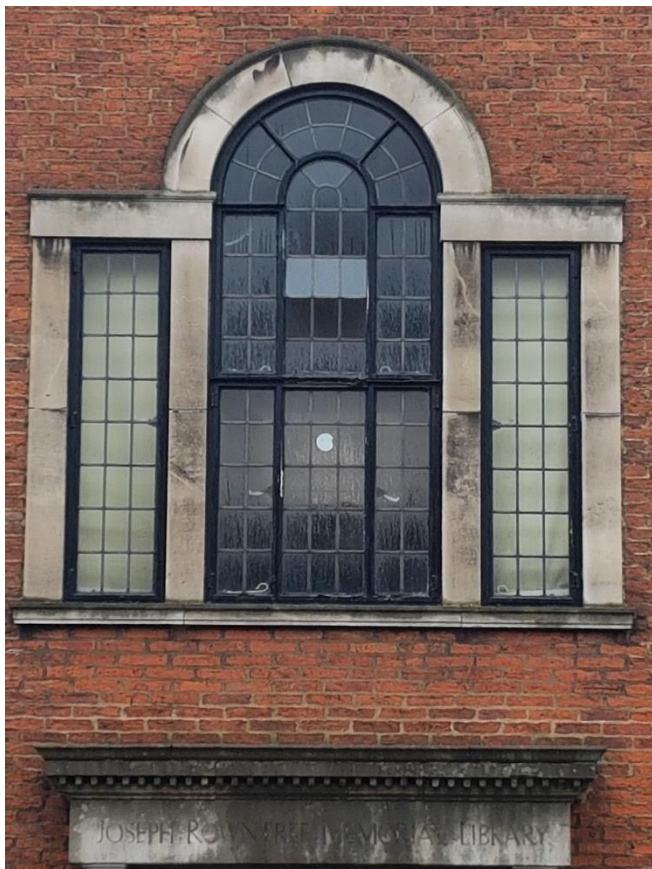
The main features of the central gable end are the large Venetian Window, and the vestibule and doorway below (Figure 9 & 10). The gable follows the shape of the standard pitched roof of the centre of the structure, however it features a parapet or gable step, which follows the shape of the roof and is topped with a coping of stone slabs. The gable step is squared off at the ends, reminiscent of a gable kneeler, though with no decorative stone beneath (Figure 12).

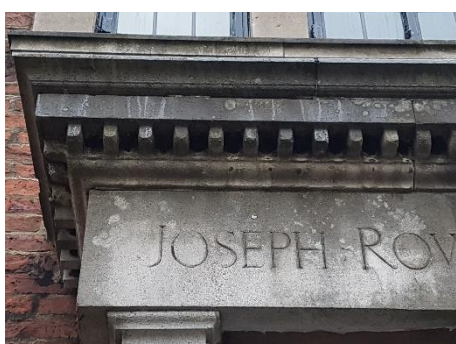
FIGURE 11

The decorative vestibule is fronted by two square pilasters which have wide rectangular recesses in both visible surfaces, which stretch most of the length of the column, beginning at the bottom from just above the level of the top step of the entrance-way, up to a few inches from the top of the stone brackets. The recesses in the pilasters feature decorative moulding on the internal angle running around the entire recess (Figure 15). The stone brackets also feature a fluted pattern on the outward concave outward facing surface, with the profile showing a floral design (Figure 16). The brackets support the entablature above, which has a chamfered cornice, decorative modillion frieze, and the architrave is engraved, reading 'Joseph Rowntree Memorial Library' (Figures 11, 13 & 14). The architrave is in fair condition; however, the cornice and frieze are showing signs of damage with deep cracks along the front edge stretching vertically.

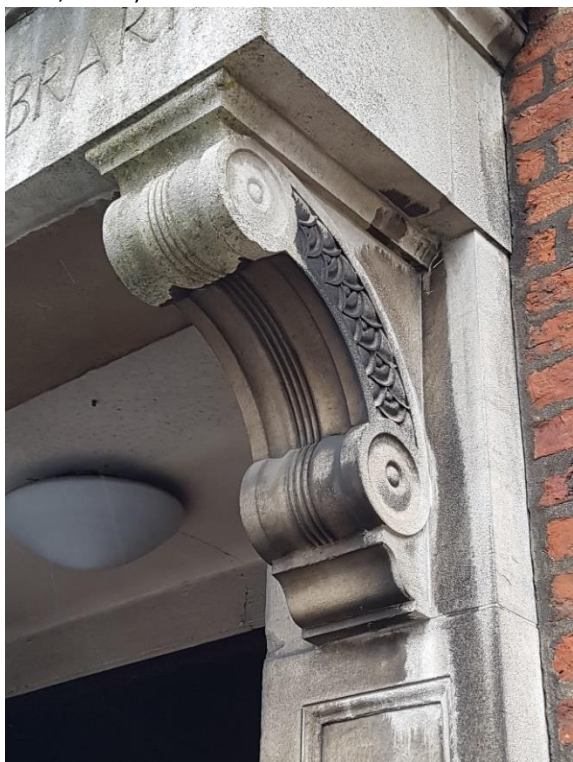
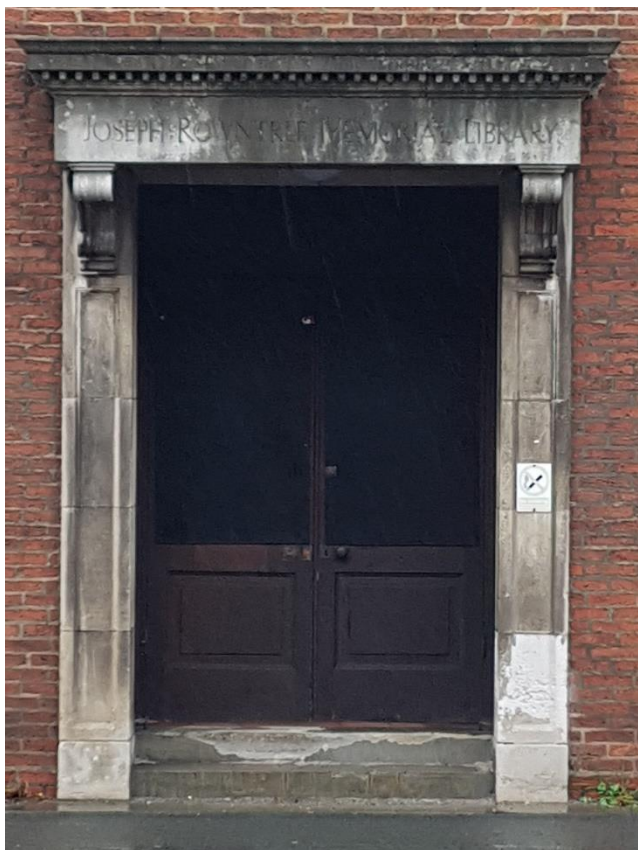
The pilasters and entablature are likely constructed from limestone, as the stone work has indications that the exposed elements are being kept clean when the soluble magnesium sulphate is washed away by rainwater. Correspondingly, the recessed areas and areas more protected from the rain have accumulated pollutants, forming black deposits on the structure (English Heritage, 2012, 68-69).

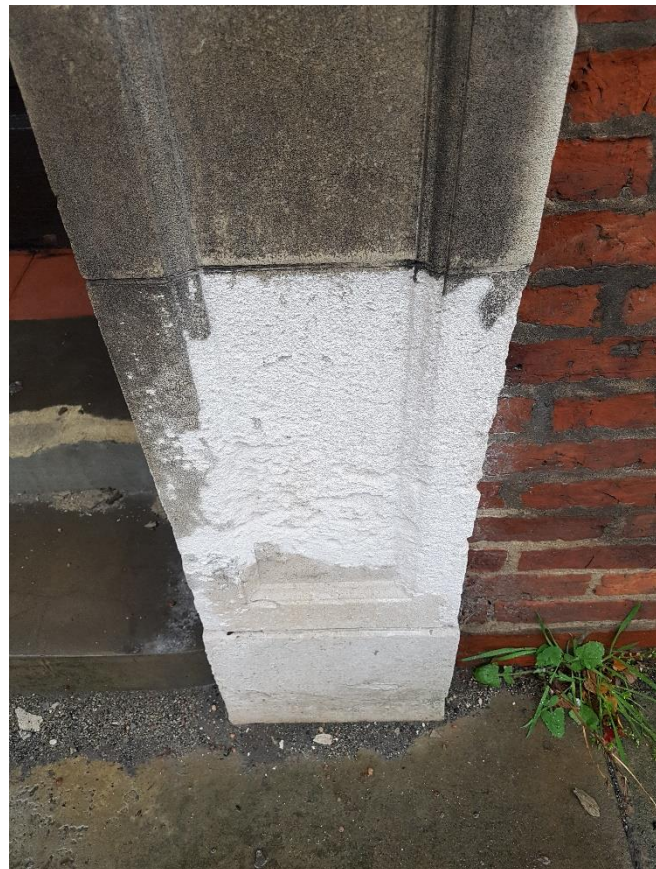
FIGURE 17

Significant surface detachment has occurred in elements of the pilasters (particularly in the lower right portion of the right pilaster), and in the steps (Figure 17). There are areas of the pilasters and entablature that are relatively exposed but still have a noticeable build up, which could be a product of the proximity of the entranceway to the main road, making it easier for pollutants to build up during the crystallisation process.

Reminiscent of contour scaling in sandstone, the erosion to the pilaster may be a product of extensive exfoliation of the surface layers (English Heritage, 2012, 110). It could also have been exacerbated by frost action, though this raises questions as to why similar erosion has not occurred in the left pilaster.

Other indications are that the subway which joined the factory with the dining block over the road (now the Nuffield Hospital) is flooded to some extent. It is possible that water drainage issues under ground level may have contributed to the erosion around the lower portion of the building.

Further investigation into the above is therefore recommended moving forward.

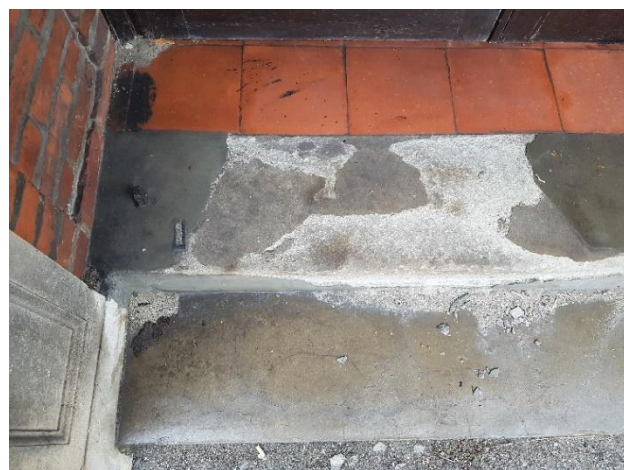
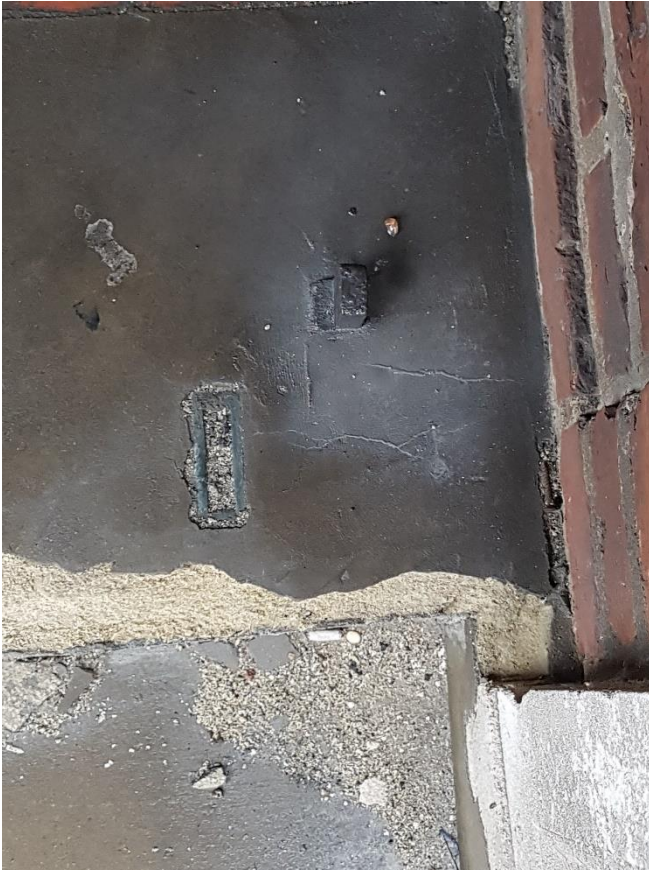
The stone steps have also been subject to significant erosion, particularly the top step, which again has the appearance of contour scaling (Figure 18 & 19). On closer inspection, it would appear the steps are possibly rendered stone, with the lower step demonstrating initial cracking in the surface, which in the case of the upper step has, through frost action, wear or some other erosion (or all the above), resulted in significant spalling and degradation of the surface, exposing the stone underneath.

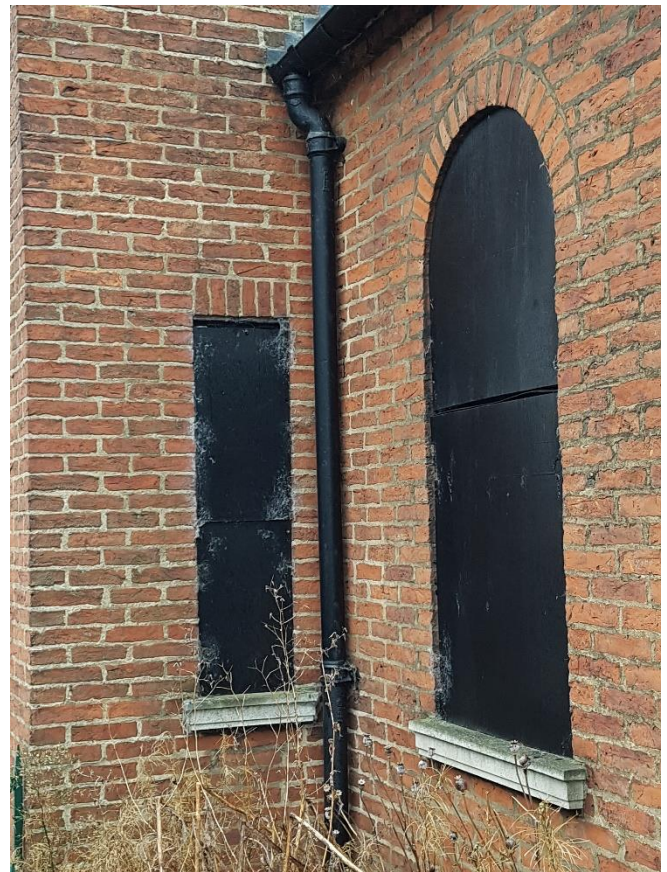
FIGURE 20

The central section is flanked by two more gabled cross wings running perpendicular to it, and are symmetrical in their design. The eastern elevations of both these wings feature three round-headed windows reminiscent of the style seen in the centre portion of the Venetian window of the centre gable end. The central gable protrudes forward from the cross wings; in the side walls of the central section are two further square-headed windows (Figure 20).

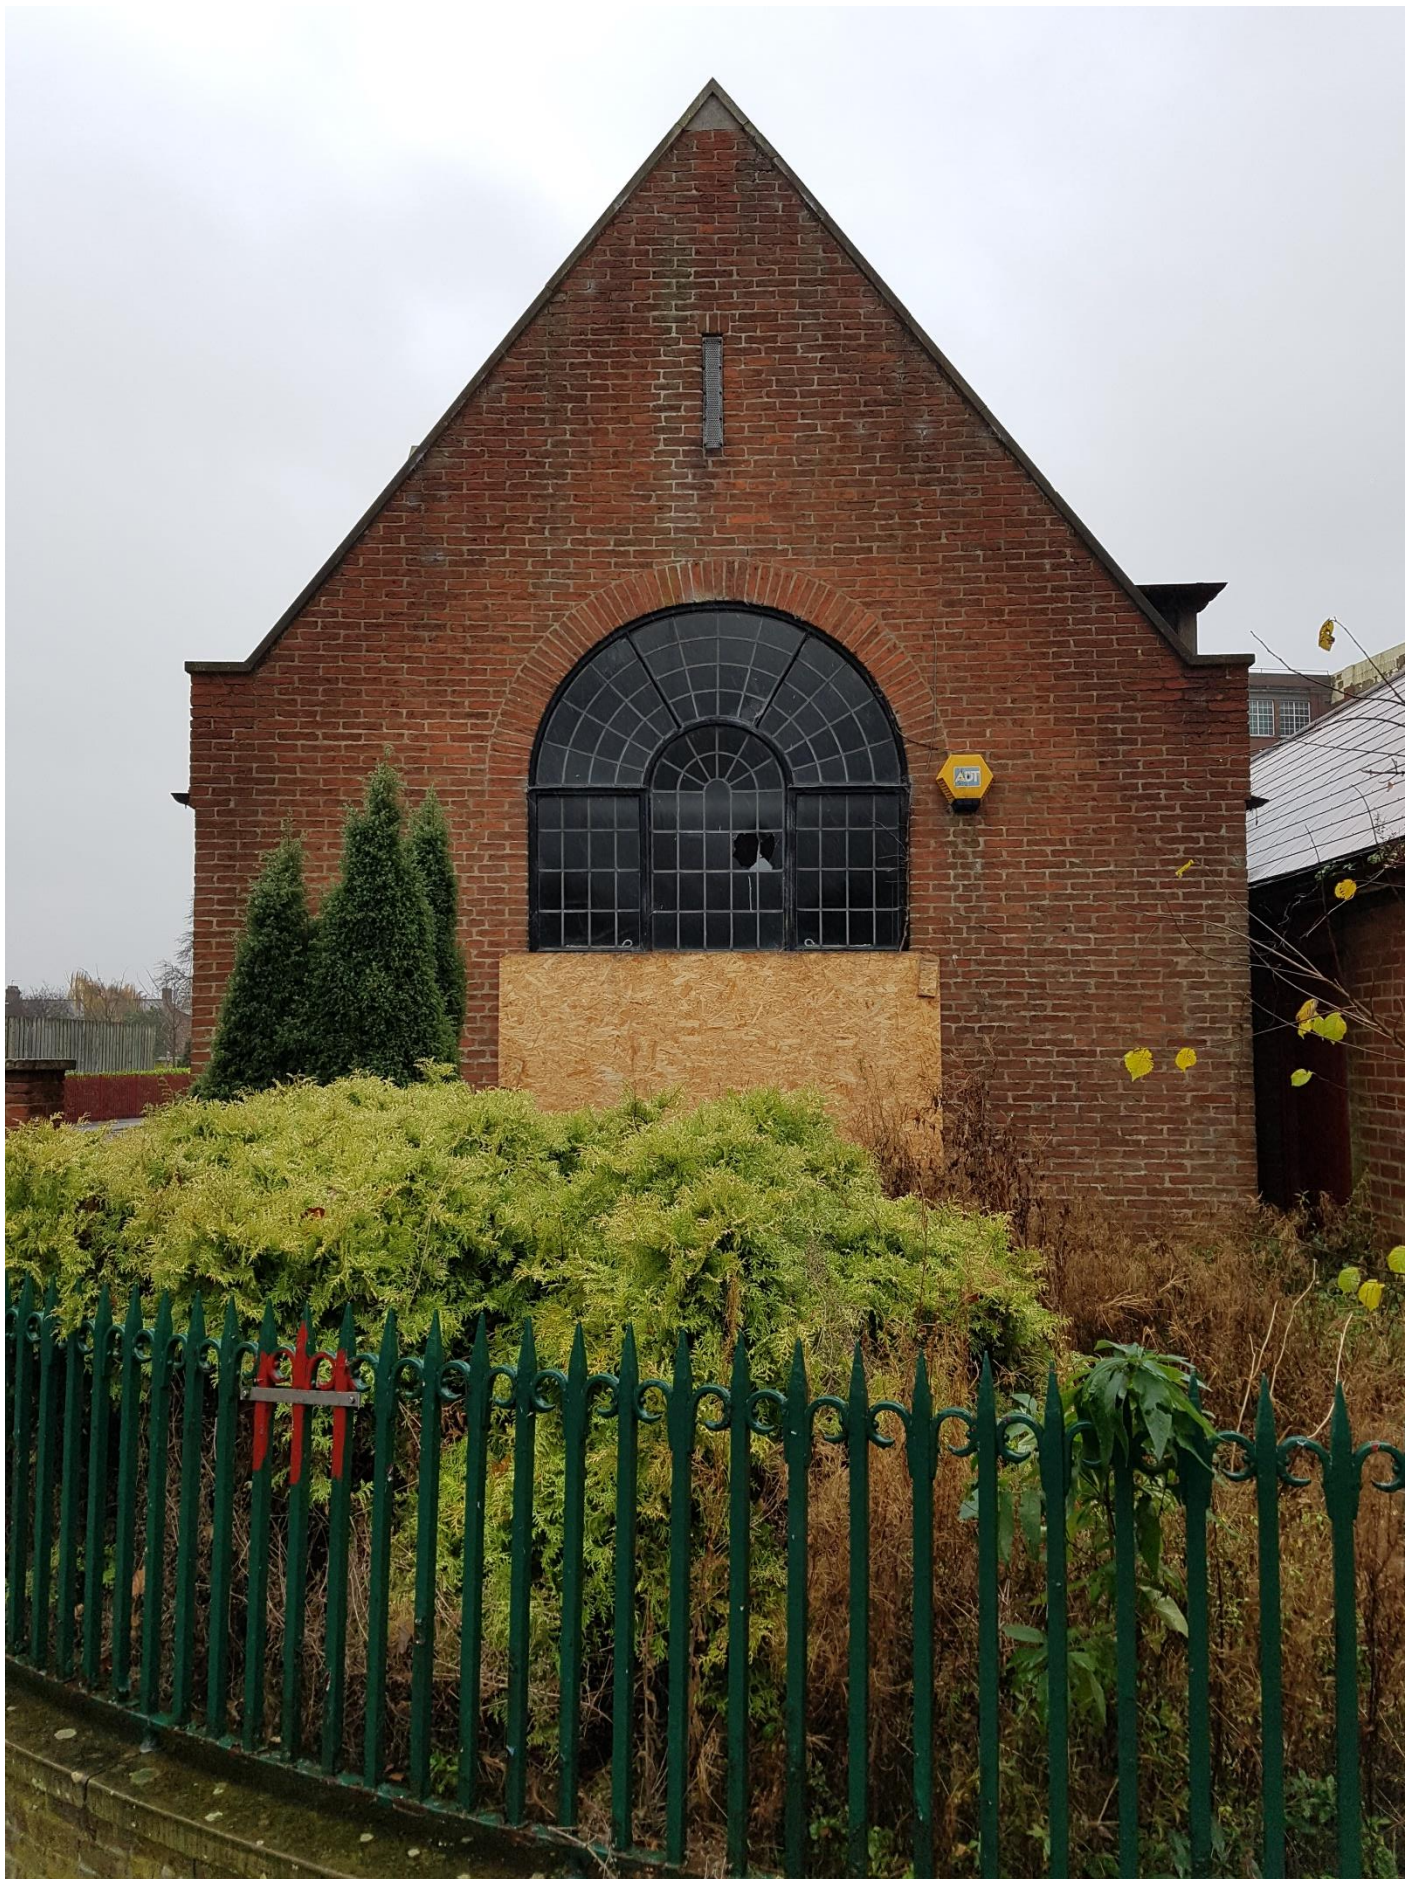
FIGURE 21

The north elevation (Figure 21) is the gable end of the north wing of the Library itself, which is styled similarly to the central gable end, comprising a gable step with kneelers. The main feature of the gable end is a large round-headed window, similar in style to the central portion of the Venetian window seen on the east elevation. The window is partially boarded up, with the upper half being exposed, showing that one of the panes within the leading has been broken, presumably as a consequence of vandalism (Figure 22).

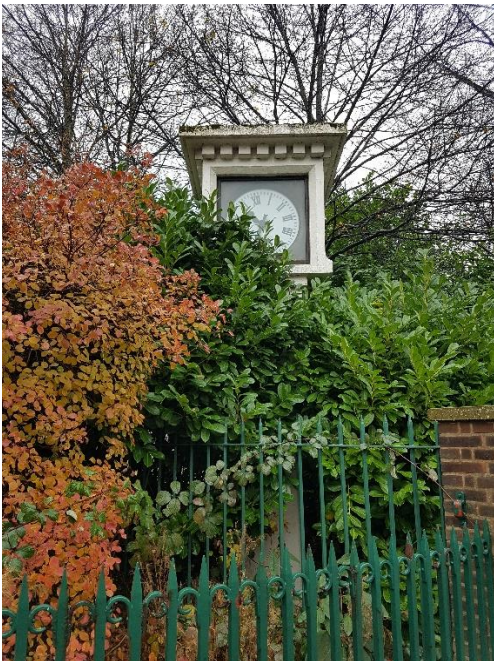
FIGURE 23

Of additional note, not included in the listing, but included in the Nestle Rowntree Conservation Area, is the Rowntree factory clock (Figure 27), facing southward along Haxby Road, and situated close by to the J R Memorial Library along Haxby Road to the south of the Library. A similar clock can be seen opposite the north elevation, though it is obscured somewhat by plant growth (Figure 23).

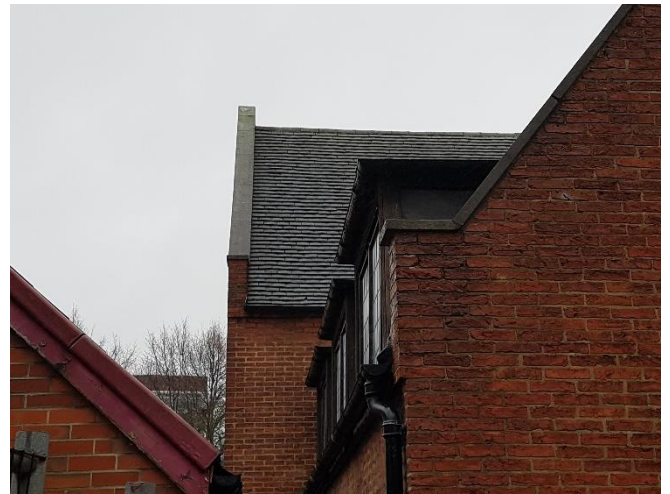
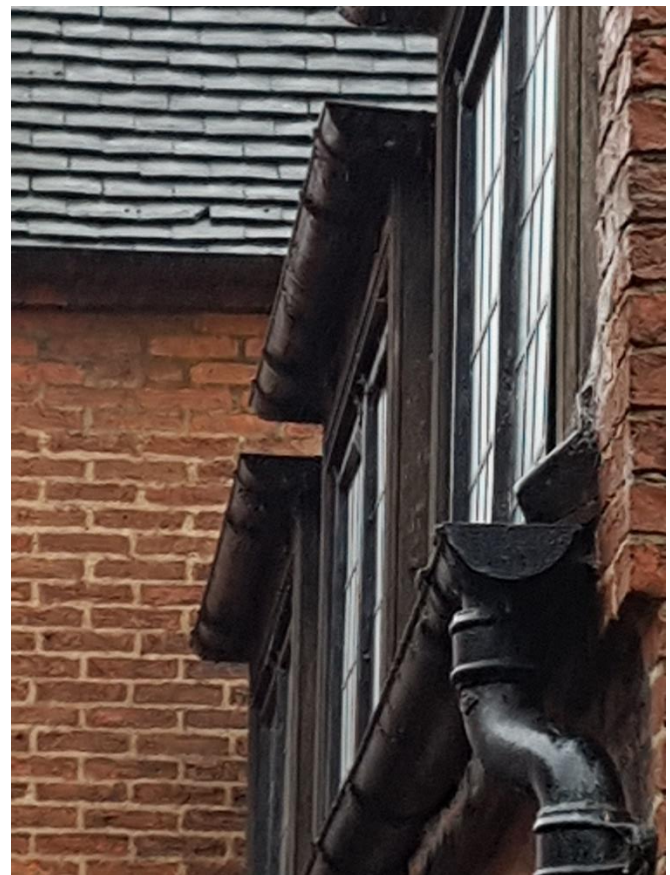
visual analysis. What can be seen are the profile of the square headed dormer windows which have flat rooves, and three per wing (Figures 24 & 25). Given the extent of the single-storey structure to the rear these windows are likely to be largely obscured when viewed from ground level.

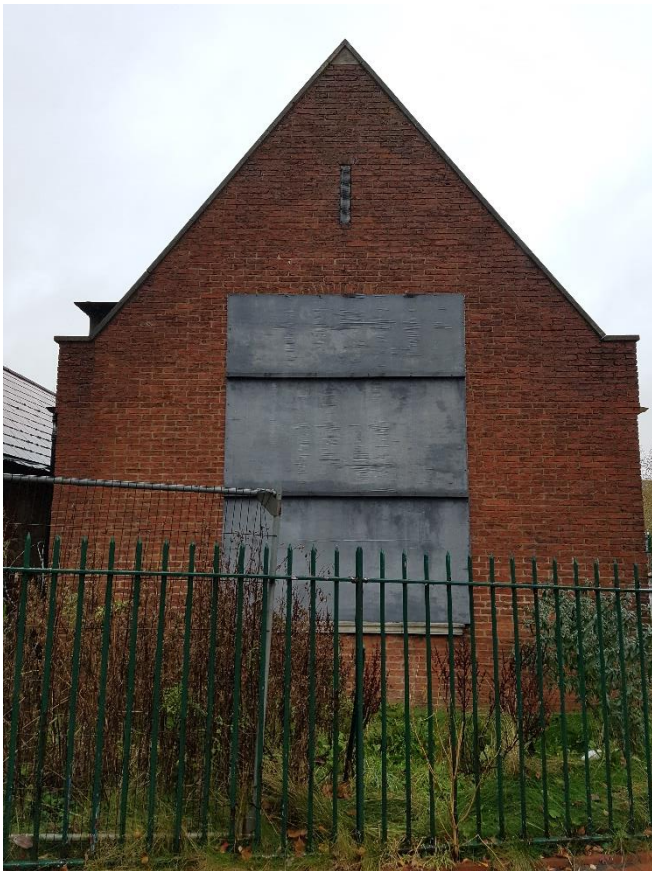
FIGURE 26

Features of the gable end are as per the north elevation, with a single large round-headed window being the main and only feature. It is worth noting that unlike the north elevation, the entire window is covered in the black wooden protective panelling as per all other windows on the ground floor (Figure 26).

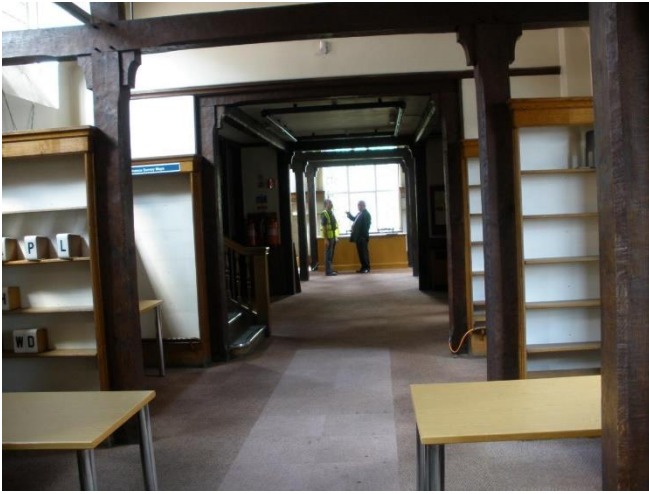
Internally, we are presented with exposed timber frames throughout the building. The central hall of the Library features four oak posts topped by four oak beams which support the upper floor; a feature of this section only. Opposite the entrance way is a stairway leading to this upper floor, and in the original designs a reception counter was situated on the ground floor in front of the staircase. Based on recent internal images (Figure 28), it would appear this counter is no longer here, with a contemporary replacement counter at the end of the north wing (Figure 29).

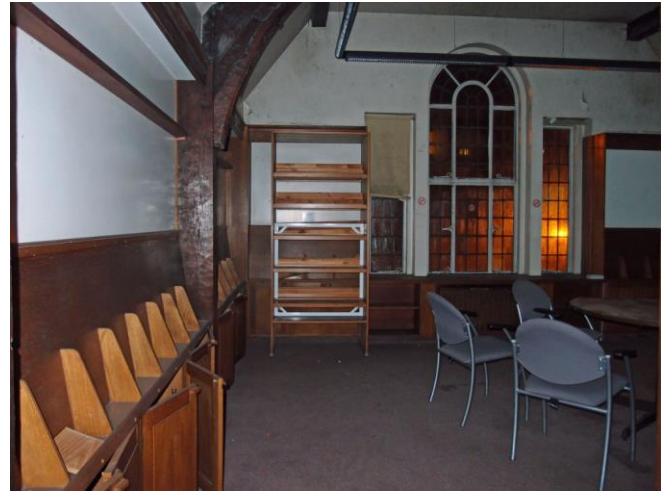
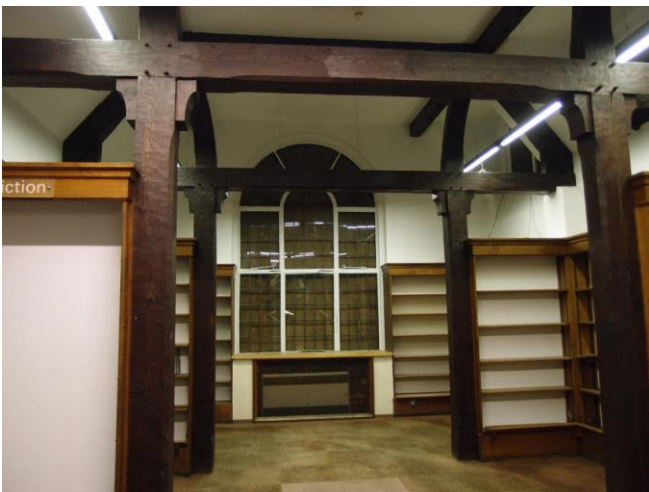
The wings are virtually identical with the exception of the above, and again feature two pairs of posts, in this instance supporting tie beams which run between internal projections from the brick wall structure which support the beam ends. The construction initially has the appearance of a clasped purlin roof, however, the lateral purlins run through the principal rafters and are as such not tied into the curved posts which sit upon the curved oak posts projecting up from the tie beam. Furthermore, collar beams run from the level of the purlins in line with the curved posts and principal rafters, supporting the ceiling rafters above.
